NOMINATION FORM
for the
NATIONAL REGISTER OF HISTORIC PLACES, NATIONAL PARKS SERVICE

1. NAME				
COMMON:				
Green Spring Valley Hounds Club House				
AND/OR HISTORIC:				
Stanford				
2. LOCATION				
STREET AND NUMBER:				
Southwest side of Mantua Mill Road				
CITY OR TOWN:				
Glyndon				
STATE		COUNTY:		
Maryland		Baltimore

STAMFORD, the Philpot House, is a brick, two and one-half storey, five bay, gable-roofed house, its principal facade to the east, with a brick, two storey, three bay, gable roofed north wing, and a brick, one and one-half storey, three bay, shed-roofed west wing. The west wing is bonded into the main house, apparently of contemporaneous construction, while the north wing is not; the latter has no south wall, the main house serving that function. The detailing of all three sections appears to date from the same period—late eighteenth century or very early nineteenth.

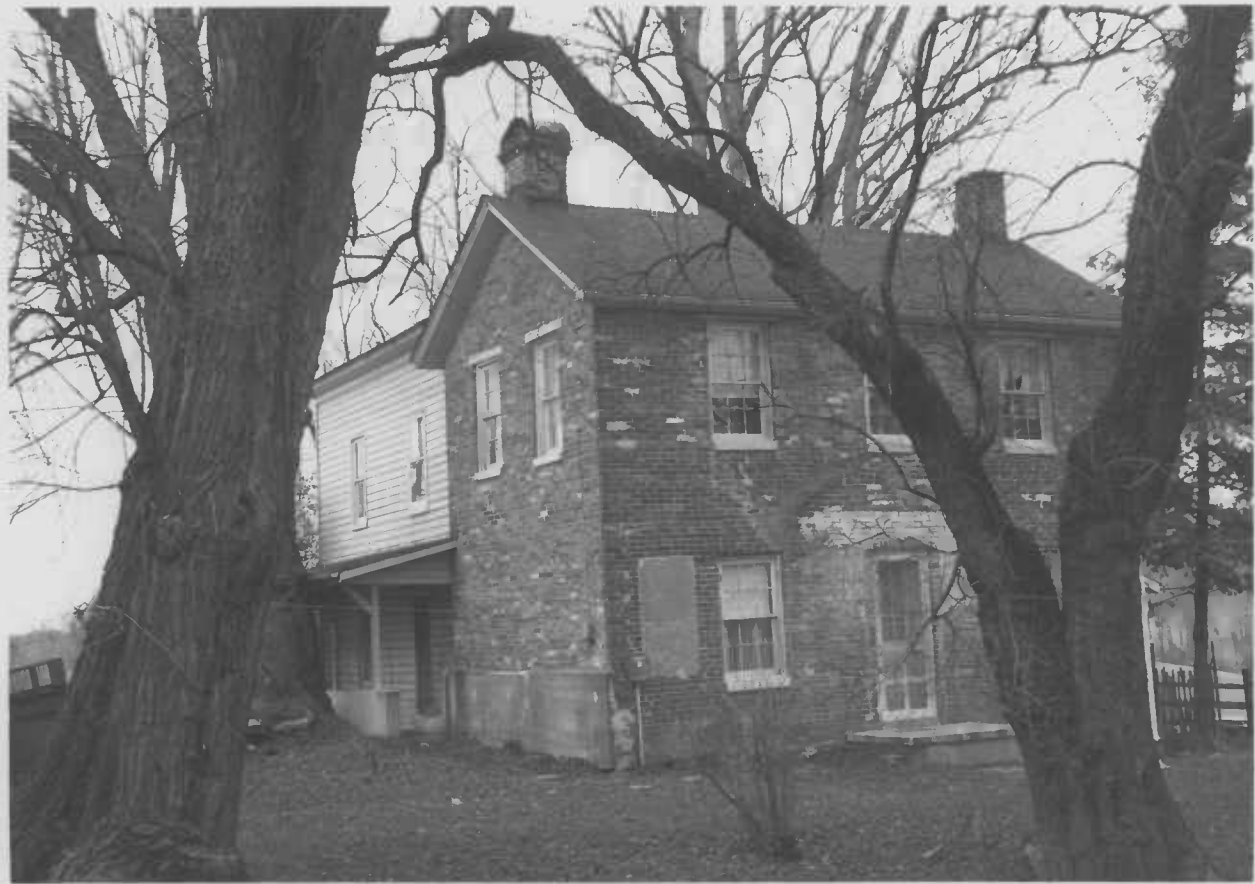
BA-171

Immediately north of the smokehouse is a brick tenant house, two storeys in height with a gable roof. It appears to have been one storey in height originally; window openings appear to have been cut through the original walls after their construction and four closed slits in its north gable resemble those in the nearby stone smokehouse, suggesting that the tenant house was originally an outbuilding, perhaps another smokehouse. Every fifth course in the original walls is a header course. Bricks of the upper storey, and those of the south end, which appear contemporary with the upper storey, are badly deteriorated, while the original bricks are in better condition. The narrowed doorway is centered on the east front and 6/6 windows are in flanking bays. Shutters and a small entrance portico are missing. Extending west is a shed-roofed frame rear wing covered with German siding, its form recalling that of the main house. The approximate dimensions of the original portion are $16\frac{1}{2}$ by 27 feet.

Stanford tennis house
from Southampton

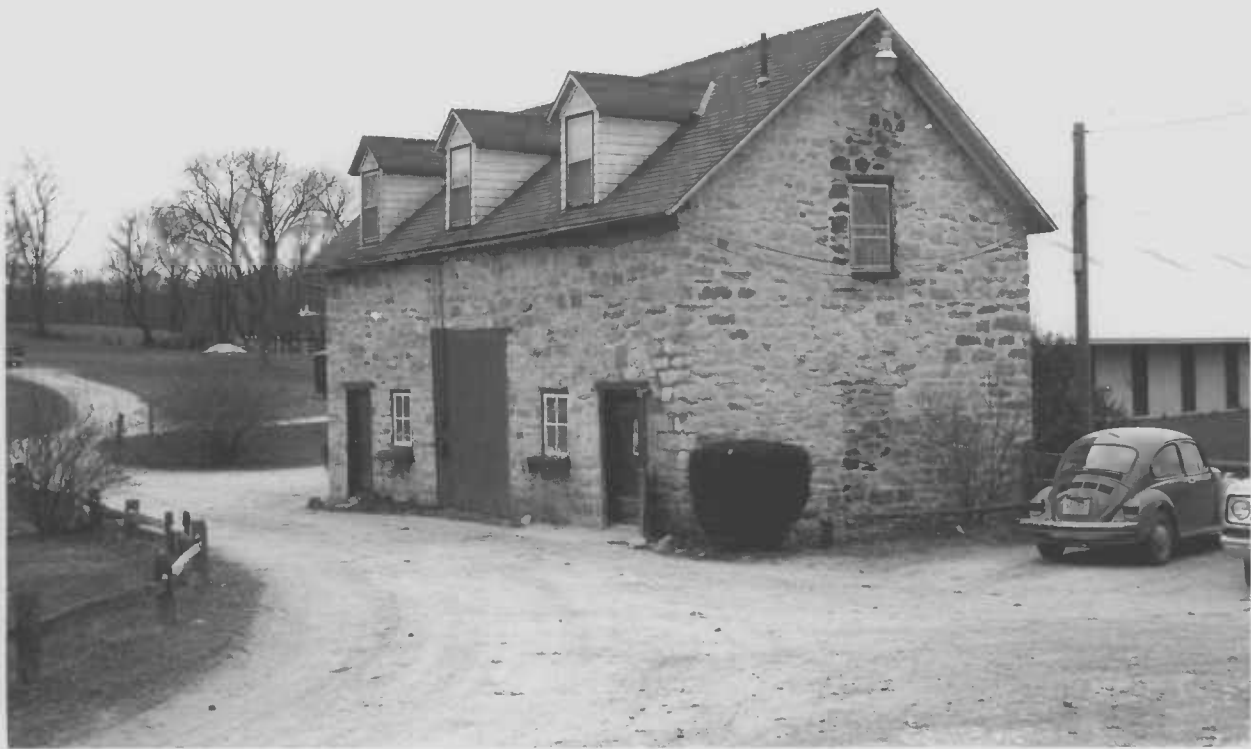
BA-171

Some distance southwest of the house is the tackhouse, which was originally a small barn or carriage house. Of stone, one and one-half storeys in height, measuring approximately 20 by 40 feet, it had a large door centered in the east (front) wall, now enclosed with framed walling. A small window and a door of conventional size flank the (former) larger door. Three small windows pierce the west wall, and three dormers light the attic storey. Interior wood elements appear to date from the twentieth century, simple and utilitarian in design.

Carnage house from northeast

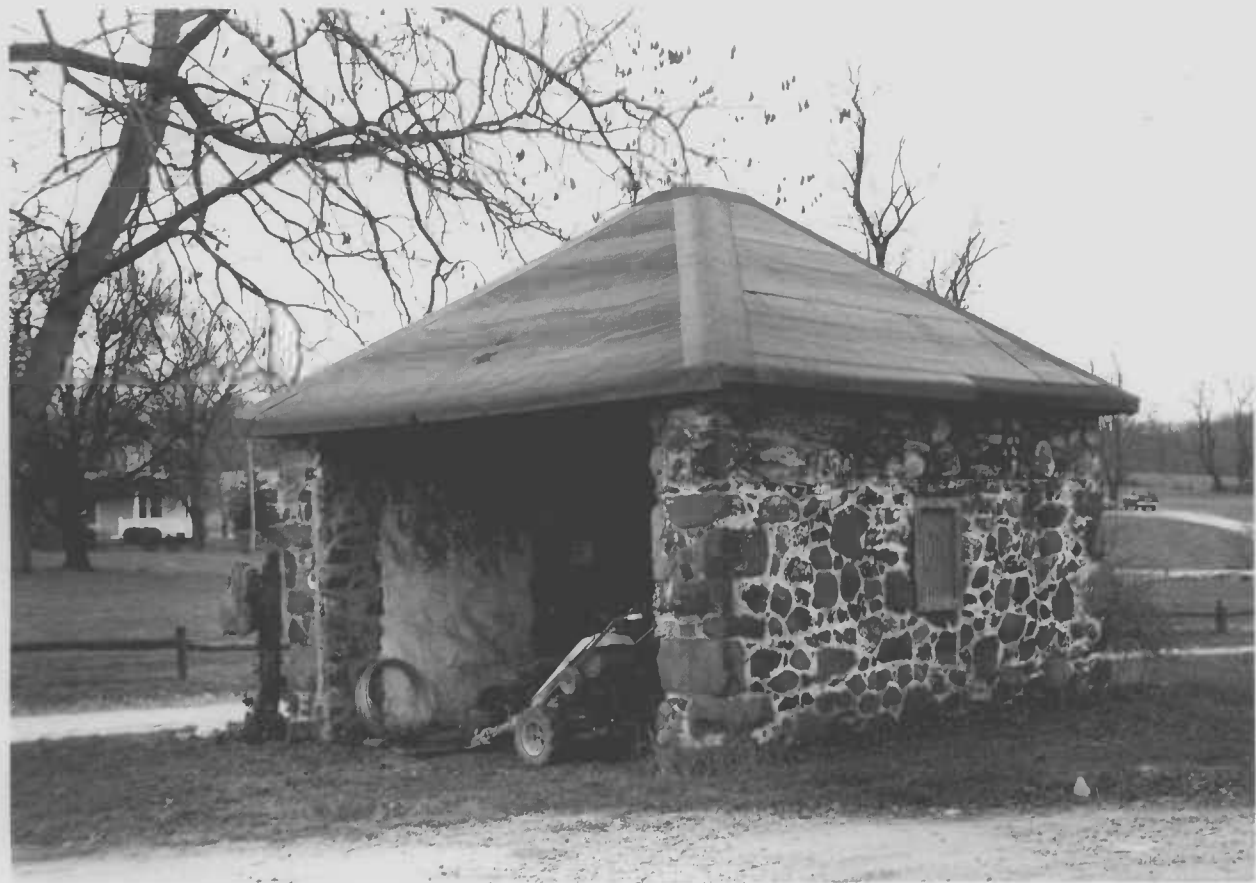
BA-171

South of the dairy house is another one storey stone structure, measuring approximately 14 by 15½ feet, with a hipped roof. Now a garage, with its east wall removed for that purpose, it was undoubtedly something else originally, perhaps related to the nearby dairy. Like the dairy, its interior was whitewashed. A small window is through both the north and south walls, and a curious row of rectangular recesses is in interior stonework high in the south wall.

Stamford - outbuilding
from northeast

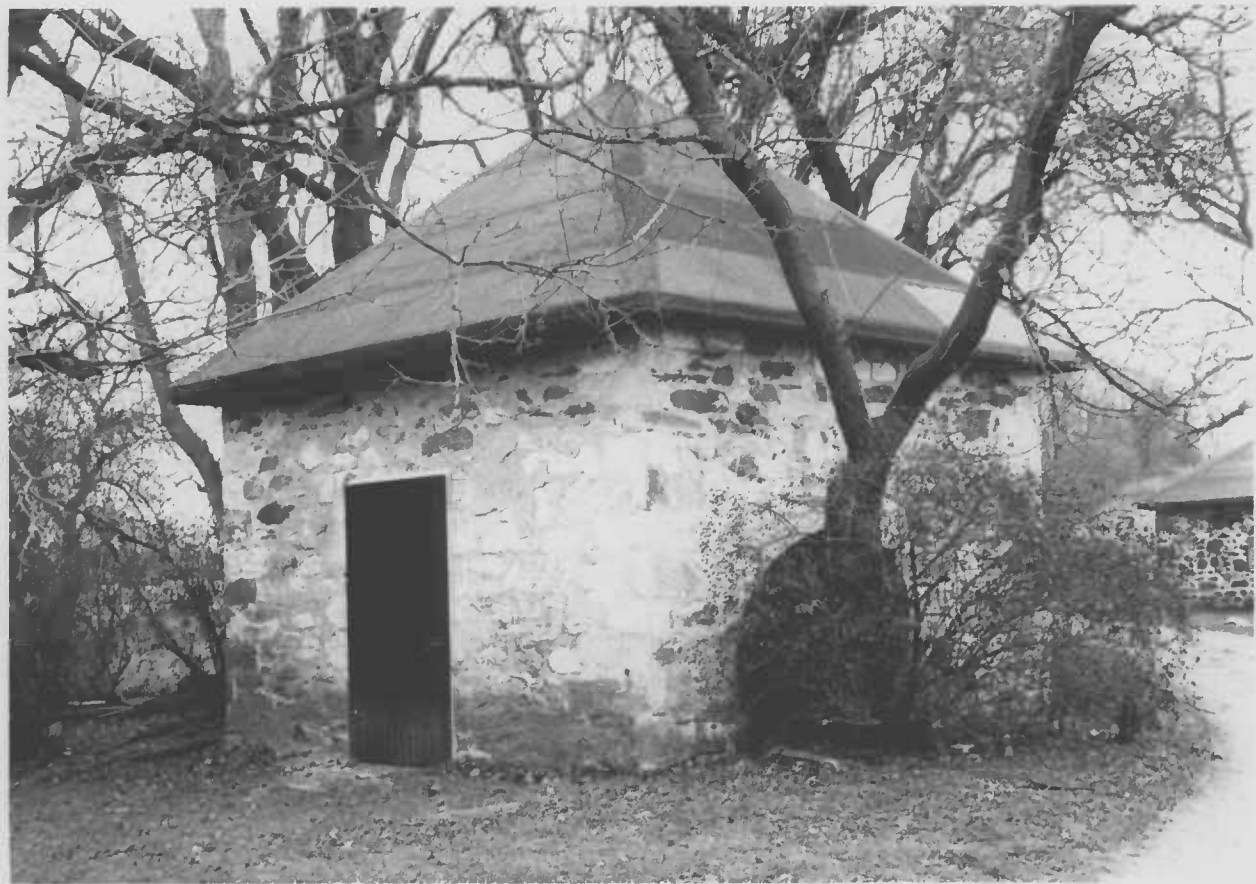
BA-171

dairy house. It measures approximately 16 feet square. Its entrance is through its north wall. A few log joists remain of a left or second floor, a few feet below the top of the walls. Window openings in both storeys of its west and south walls have been closed with stone walling, but a louvred window remains in the lower portion of the east wall.

dairy house from north-west

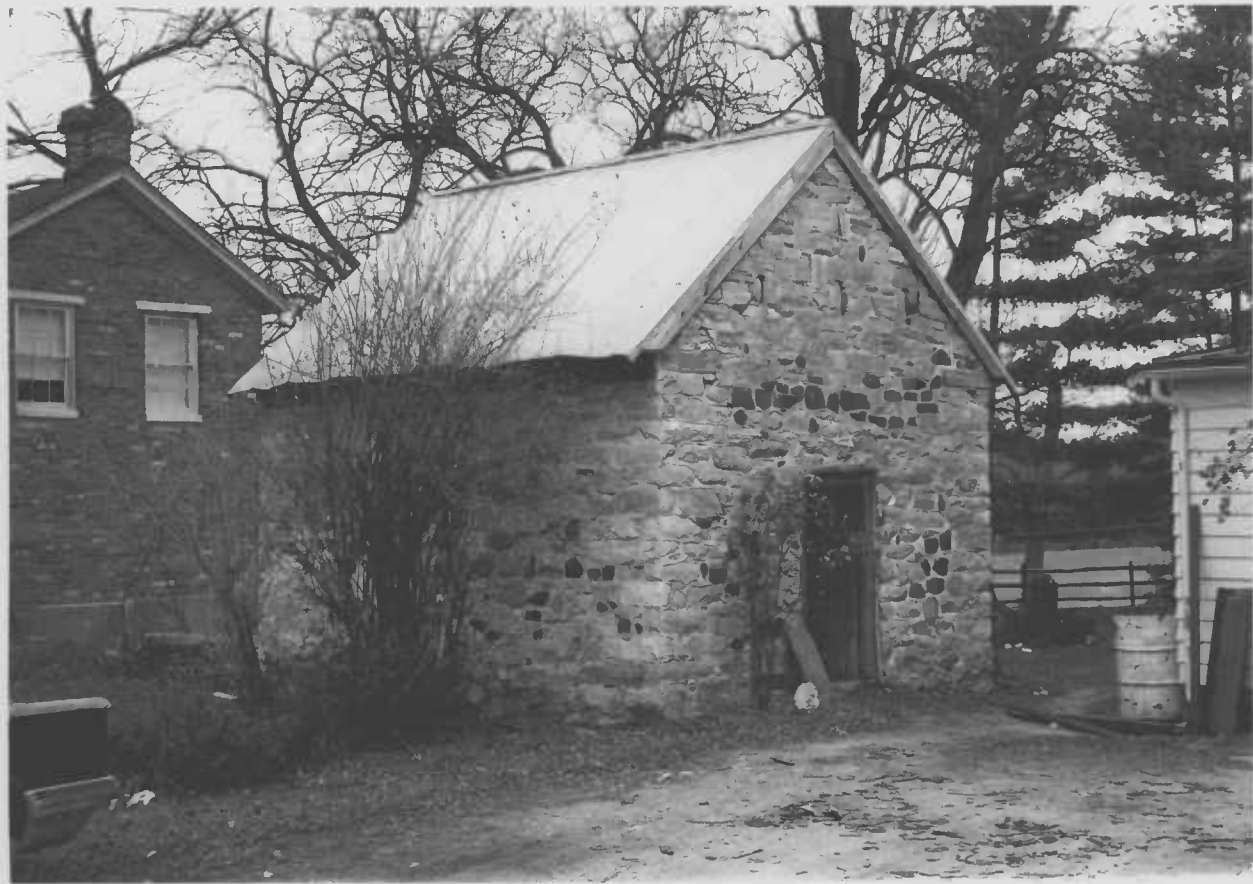
BA-171

Immediately north of the north wing is a stone smokehouse, one storey in height, with a gable roof, measuring approximately 16 by 18 feet. Its entrance is through a door in its south gable end, and four slit ventilation holes pierce each gable, near the peak.

meat house - from southwest side

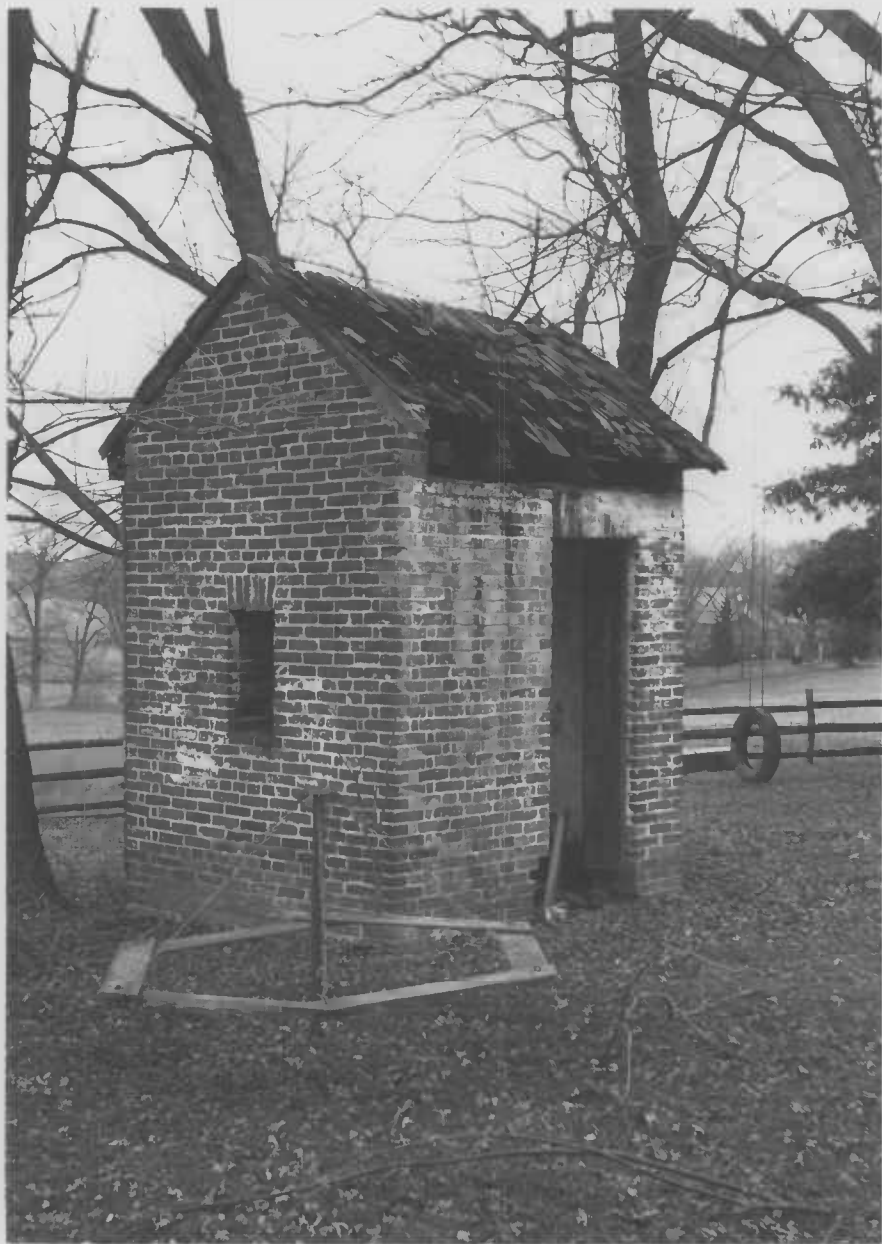
BA-171

Six early outbuildings remain; perhaps the rarest of them is the privy, of brick, 7 by 8 feet, with a gabled roof. Of common bond, with closers at the

corners, its door is through the south facade, near the east corner; masonry above is supported by a jack arch. A small window pierces each end wall, with a jack arch above. Wood elements of these openings are missing. Near the ground through the north wall is the long, low cleancut opening. Brickwork above it is falling out. Elements of a moulded cornice remain at the north eave, including a bed moulding and the ghost of a crown moulding. The entire south front cornice is missing where joist ends and reef rafters are rotted away. There was a wood floor, now entirely missing.

Stanford - price
from authors -
